#### UNITED STATES ENVIRONMENTAL PROTECTION AGENCY

**SUBJECT:** INSPECTION REPORT – West Bay Exploration Co, Jackson County, Michigan Facility: Norvell 22 CPF, Norvell Township

Date of Inspection: August 28, 2014

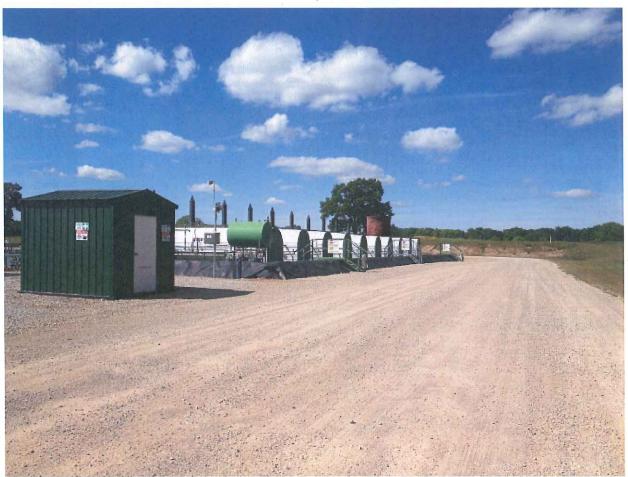
1) Heater treaters with flare in background.

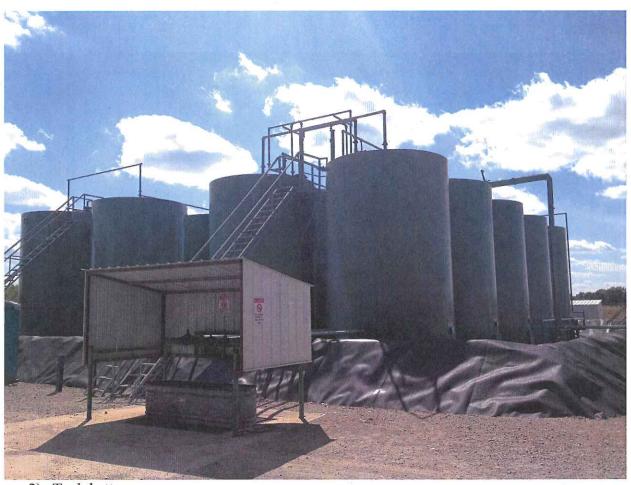
I began my tour at the tank battery. I made note of a petroleum-like odor near the tanks. Upon climbing the stairs to the tops of the tanks, I used the IR camera (a FLIR GF320) to take video clips of leaking tank thief hatches. Three of the thief hatches were leaking via the hatch seals, and one had a small leak through an associated gasket (see IR Camera Video log). I also took a video clip of the flare. The flare was lit throughout the duration of the inspection and no visible emissions (as seen with the naked eye) were noted from the flare. The IR camera video shows a gas plume moving beyond the combustion zone of the flare when viewed in high-sensitivity mode.

2) Tank battery.

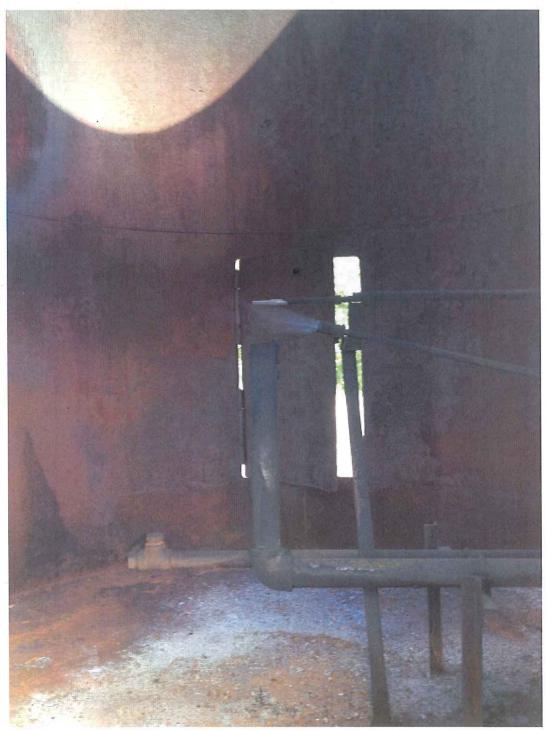
3) Flare, lit.
